Trace Examination, a Process Indispensable for the Preservative Restoration of Cultural Property Buildings

[COLUMN] Cultural Property preservative restoration sometimes rewrites regional history

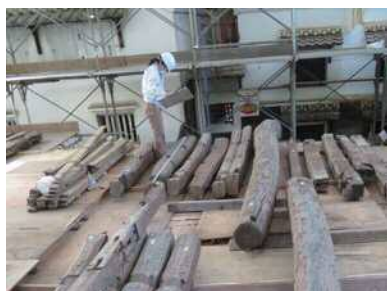
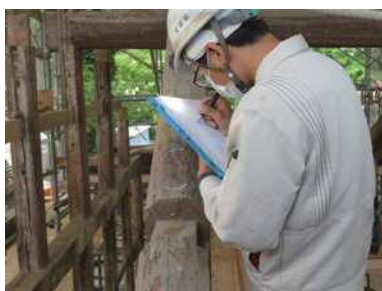
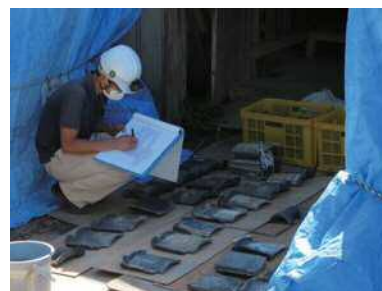
In the ongoing project for the preservative restoration of the former Suzuki family residence, a thorough examination of the dismantled buildings revealed traces of black soot on the external walls of the Buddhist altar room building, which is to the south of the main building, and black scorches on the tops of the roof rafter of the same building.

In addition, India ink writing dated the “seventh year of the Horeki era” (1757) was also discovered on the edge of a ceiling beam in the same building. These discoveries show that the Buddhist altar room building, which escaped the destructive fire in the An’ei era, is the oldest surviving building in Asume.

The preservative restoration of Cultural Property buildings starts with thoroughly examining and recording the form of building parts, the state of their deterioration, etc. Wooden buildings have traces of repairs and modifications on the wood, which offer clues about what changes the buildings have experienced. While the buildings are partly or entirely dismantled, a detailed examination is conducted on traces of mortises, nails, etc. left in building parts, as well as India ink writings on the wood.
